KPOST COMPANY HELPS BUILD THE PEROT MUSEUM OF NATURE AND SCIENCE

THE
DNA

OF ROOFING

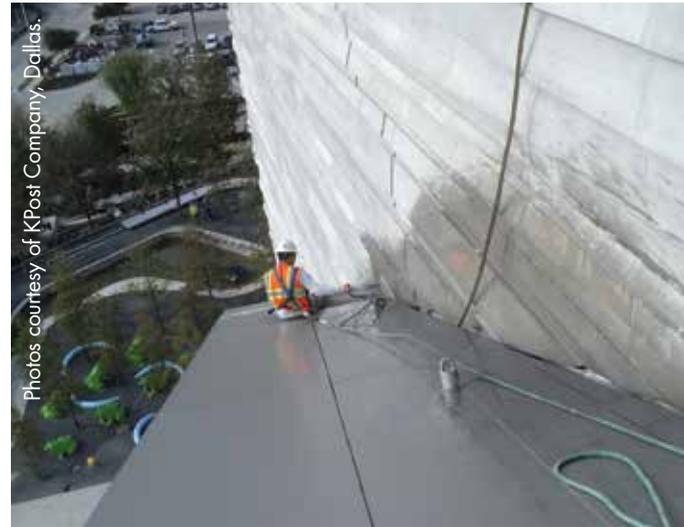
A worker tests for membrane breaches.

After completing the installation, KPost brought in an electronic leak detection (ELD) testing agency that used a low-voltage method to find membrane breaches. After testing, KPost workers installed the required high-density insulation protection boards, drainage mats and protection mats. As a safety measure, a retest was completed before the structural concrete was poured. As visitors approach the museum's entrance, they walk on the carefully constructed system.

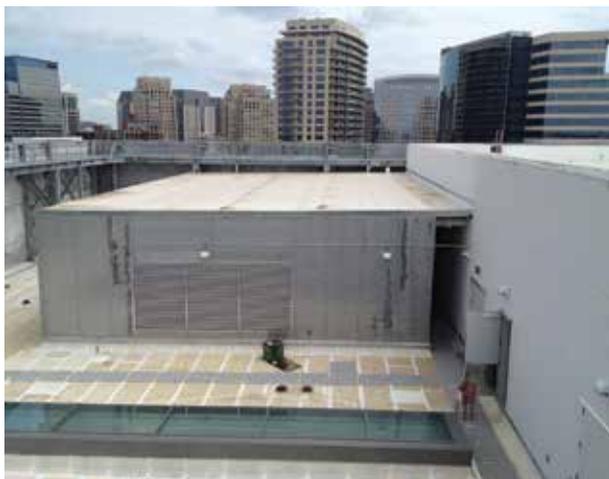
Built-up air handler unit and penthouses

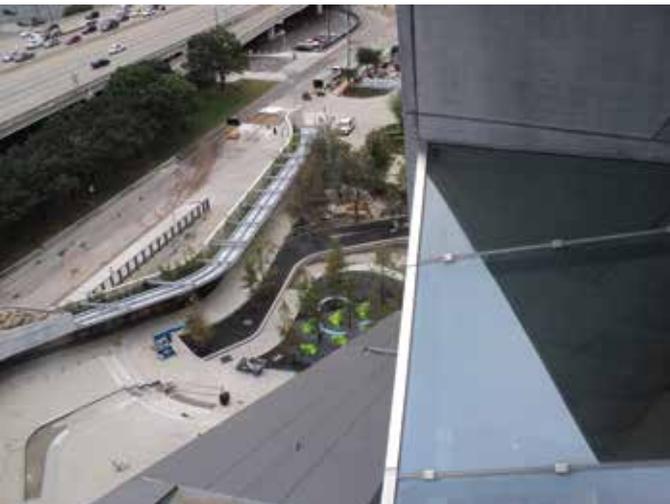
View of the plaza from the escalator access point

KPost workers installed an 80-mil fleece-backed TPO membrane roof system over the entire plaza and terrace areas. The system required the wrapping of hundreds of rebar supports for future structural topping slab tie-in. For weeks, the KPost crew coordinated with the architect and multiple subcontractors to establish curb designs that could be fully wrapped and waterproofed and, most important, allowed for forming and placing of concrete stairs, ramps, water features and planters without compromising the design intent and constructability, as well as providing a watertight system.

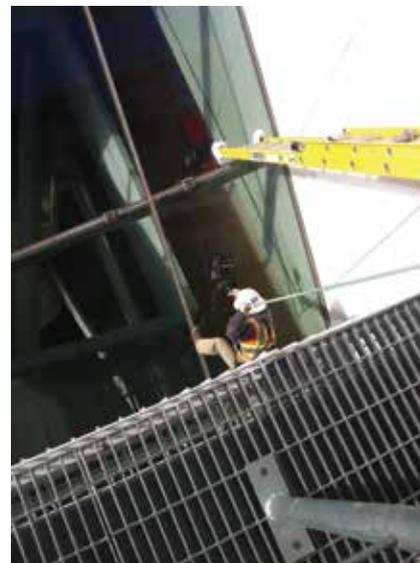
To access the cantilevered escalator structure, workers used suction cups to climb the glass surface and then repelled down the 30-degree slope roof.

The museum's escalator also was full of obstacles. The only access to the cantilevered escalator structure was through a window or from a catwalk where workers needed to use personal

fall-arrest systems above a ladder set onto a glass roof. Additionally, KPost workers had to use Woods Powr-Grip® Vacuum Lifters to allow themselves to gently climb the sloped glass surface without scratching it. The suction cups had to be moved with each step to gain access to the escalator structure. Once workers reached the escalator, they repelled down the 30-degree slope roof to access work areas.
